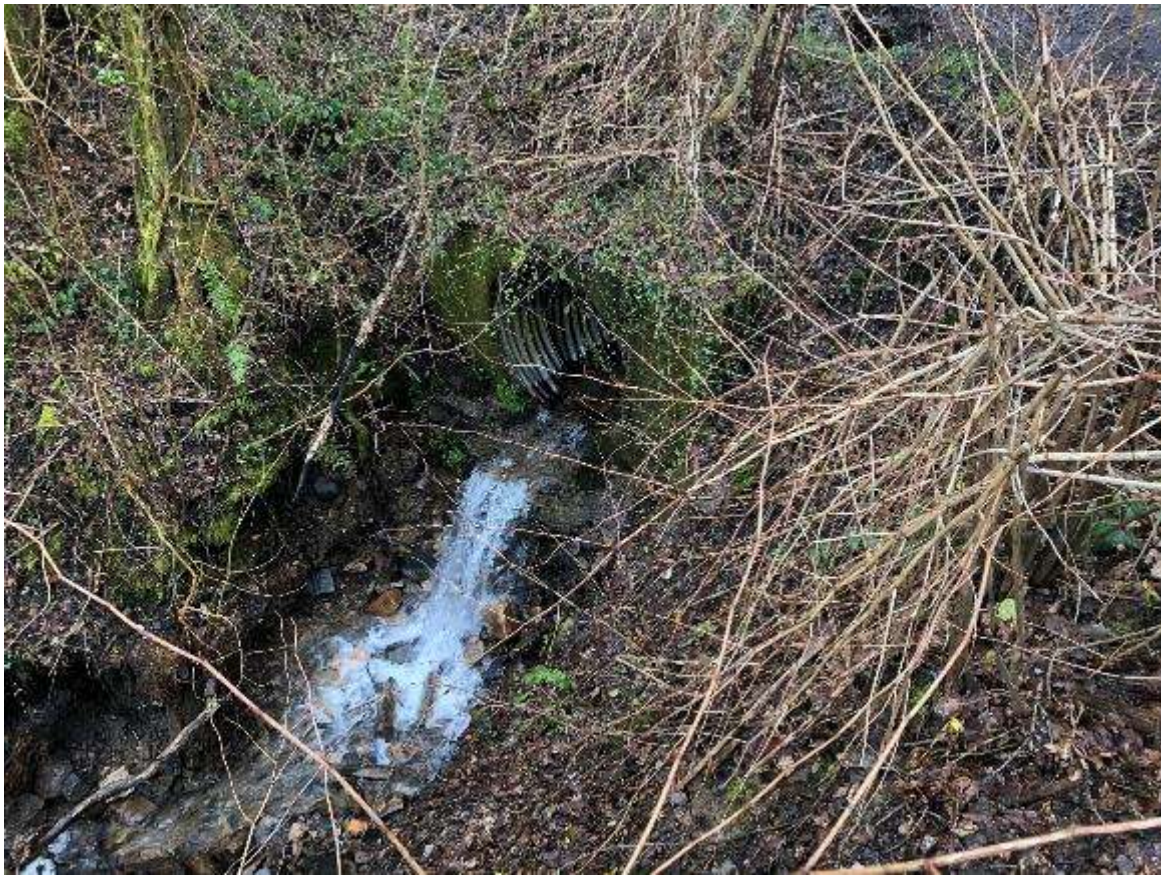
An unlined cut-off ditch is located along the toe of the western flank adjacent to Cenarth Drive and Conway Drive. The ditch was conveying flows from the flat area of ground to the north which appears to be boggy / wet. The watercourse (Nant y Groes) runs along the eastern flank / toe has caused some localised scouring, but the watercourse has found rock head and is generally confined to a narrow conduit.

*Plate 1: Nant y Groes conveyed by culvert on the eastern side of the tip – localised scour.*

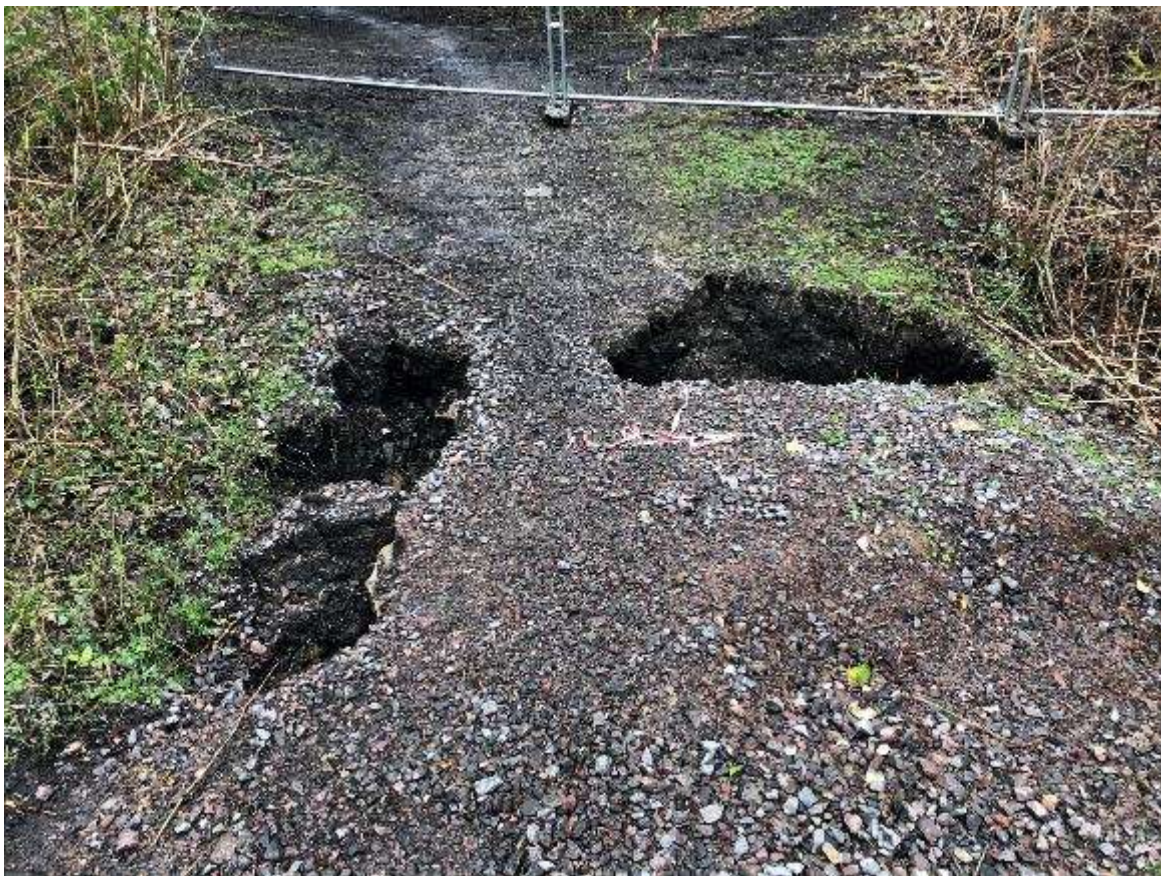
*Plate 2: Collapsed section of footpath above dilapidated culvert conveying Nant y Groes.*

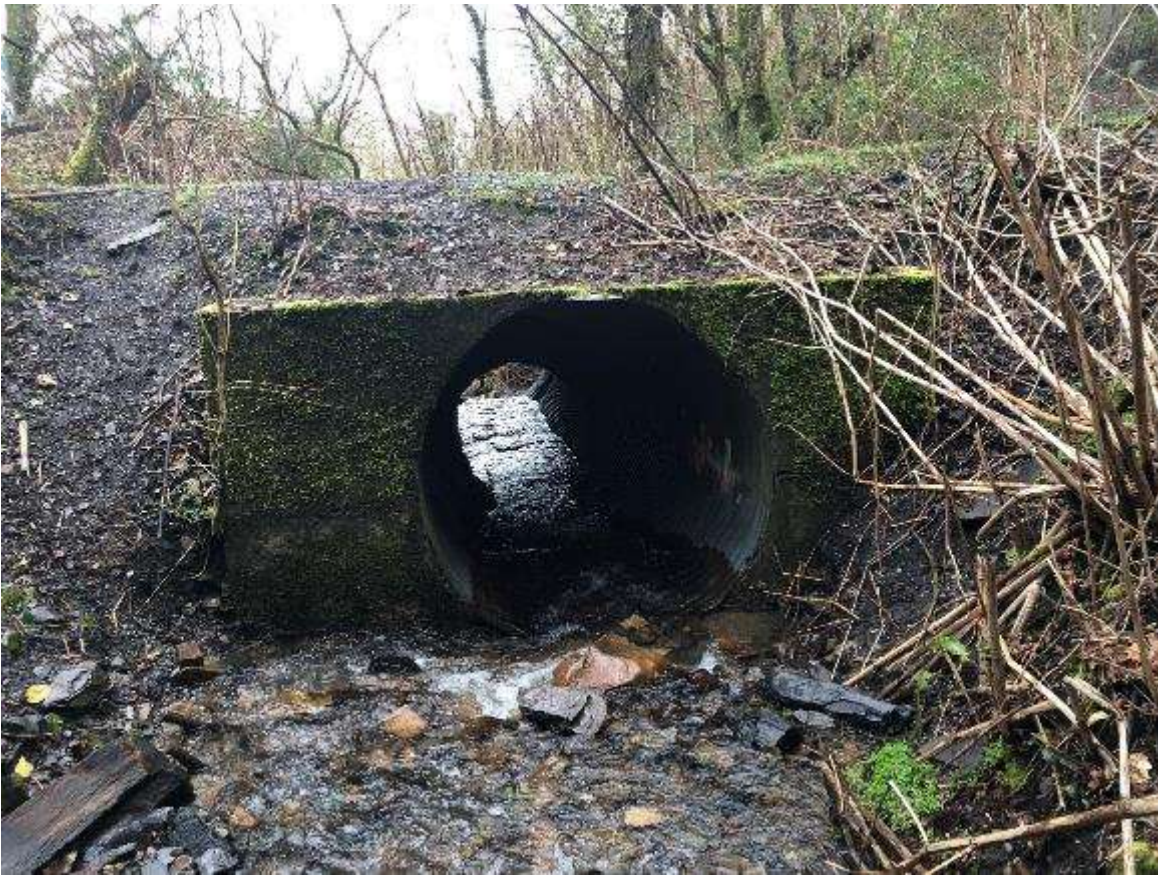
*Plate 3: Head wall of Nant y Groes culvert on eastern side of the tip.*

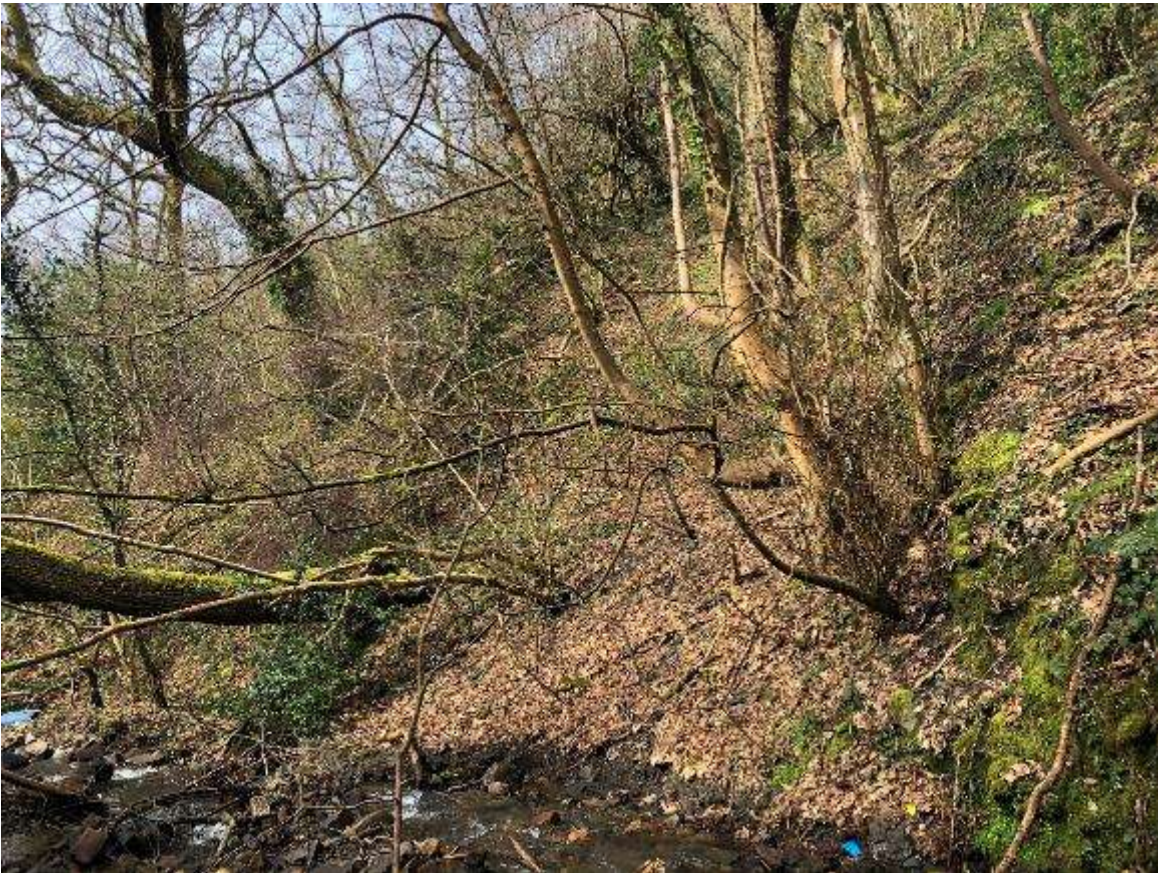
*Plate 4: View from the Nant y Groes of the eastern tip flank.*

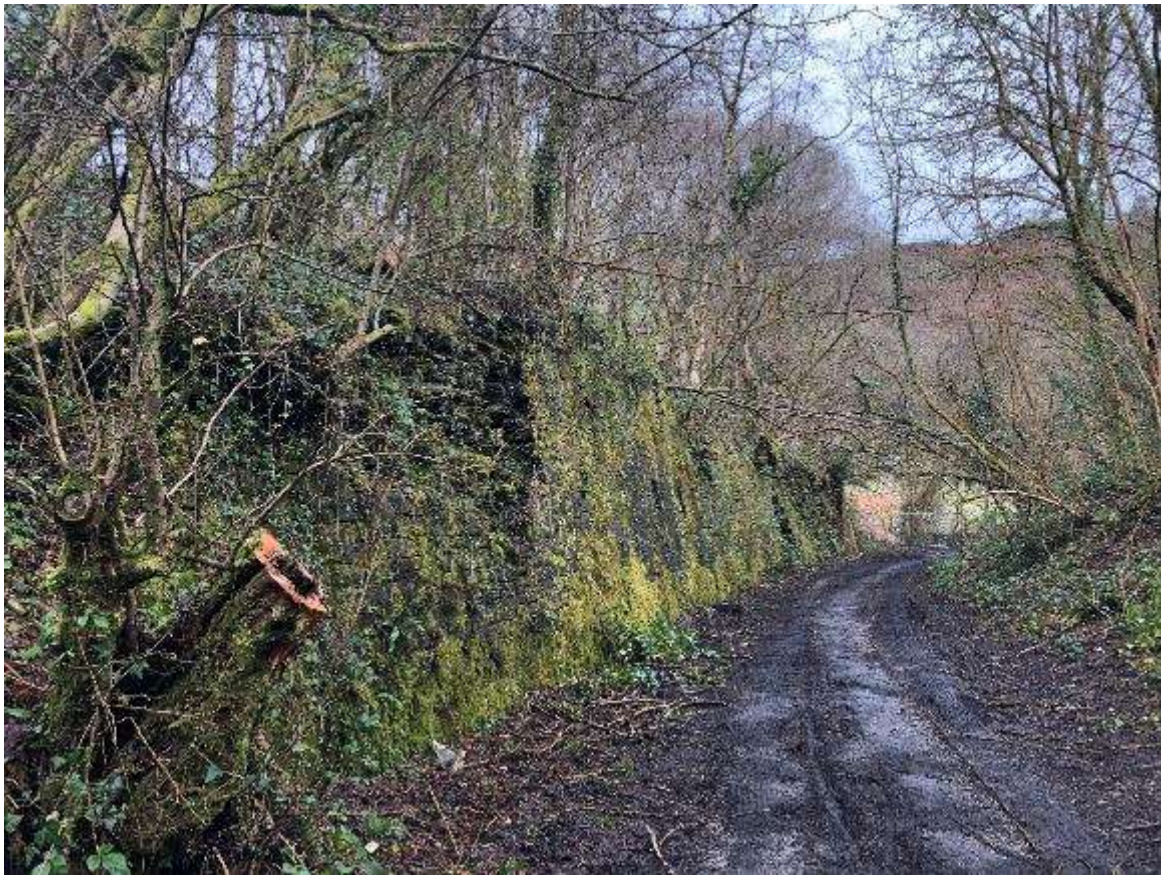
- No form of protective fencing running along the top the masonry retaining wall to the north (Plate 5 & Plate 6).
- Area of potential historical movement on the upper section of the western flank (Plate 13).
- Evidence of slow on-going creep (Plate 15).

*Plate 5: Masonry retaining wall alongside the footpath to the north.*

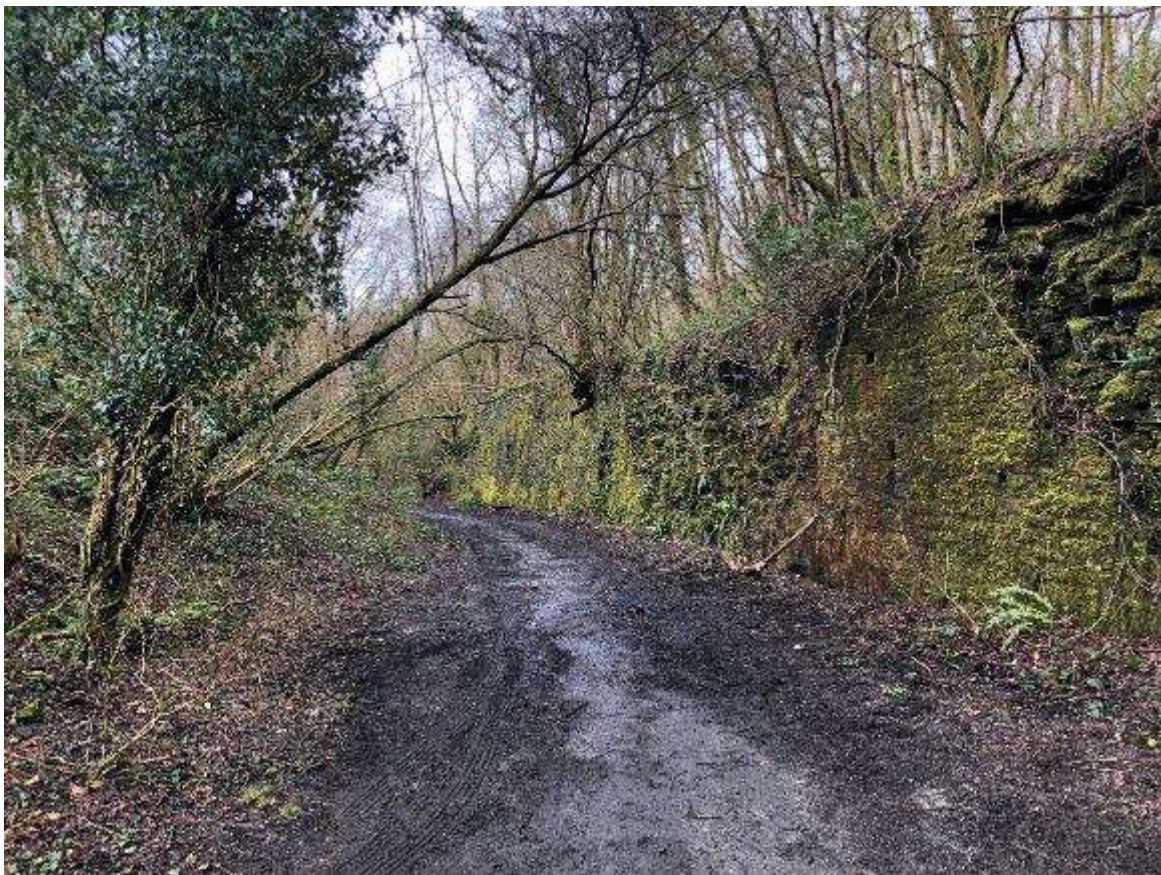
*Plate 6: Masonry retaining wall alongside the footpath to the north.*

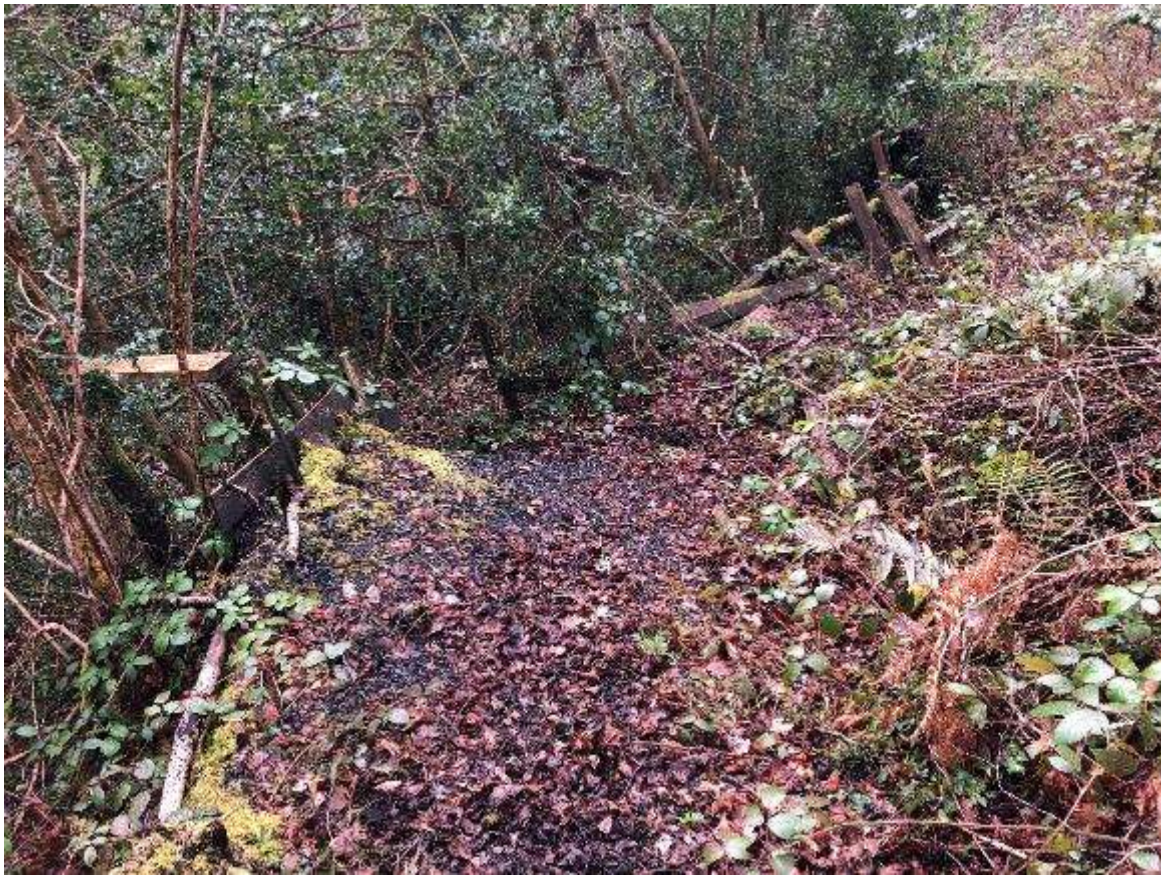
*Plate 7: Evidence of mountain bike trails on the eastern flank of the tip.*

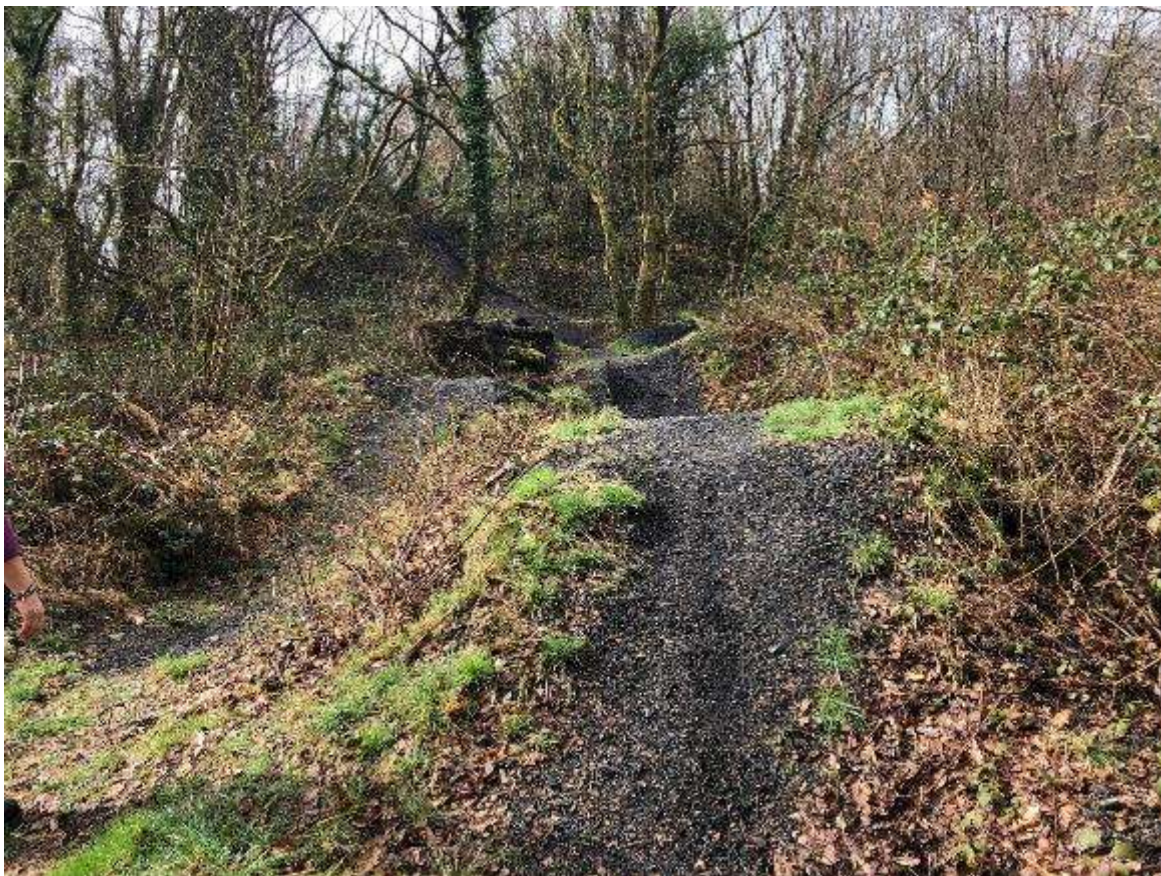
*Plate 8: Evidence of mountain bike trails on the plateau of the tip.*

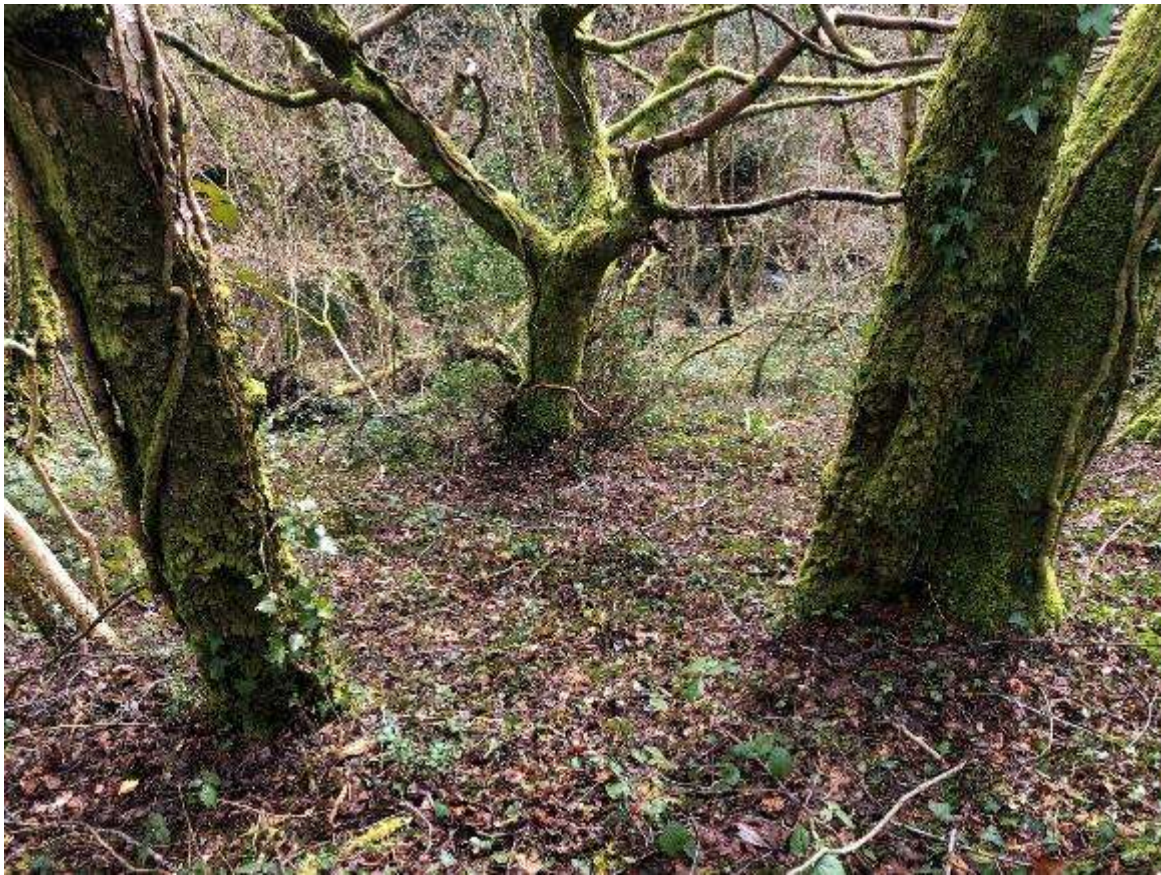
*Plate 9: View looking down the steeper section of the eastern flank.*

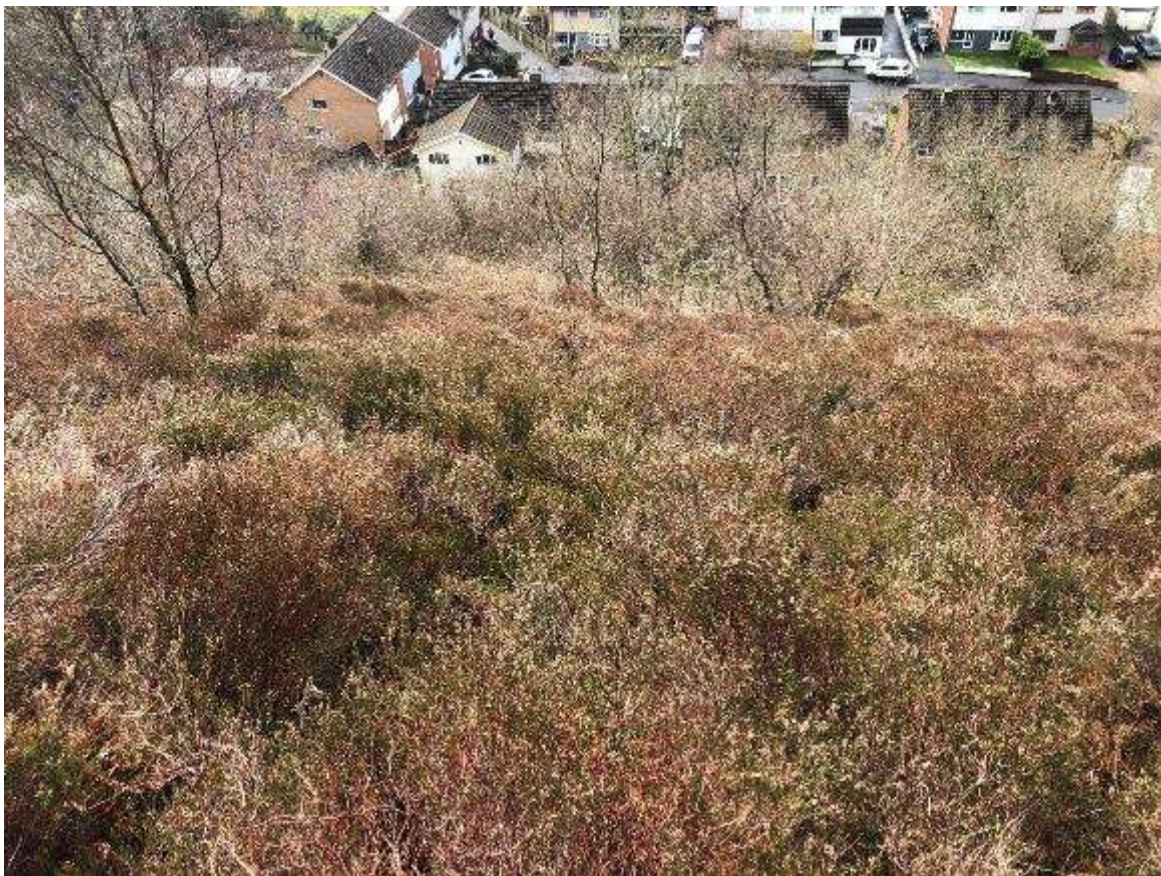
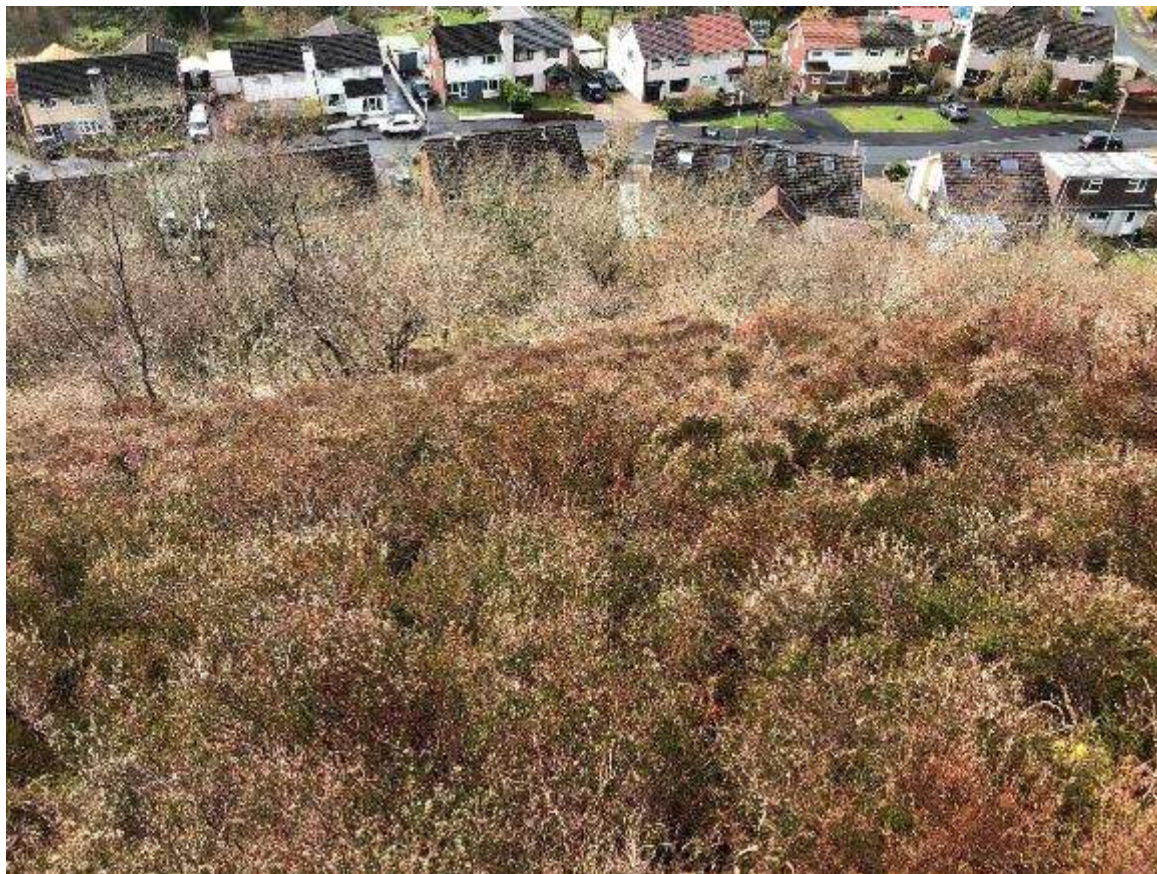
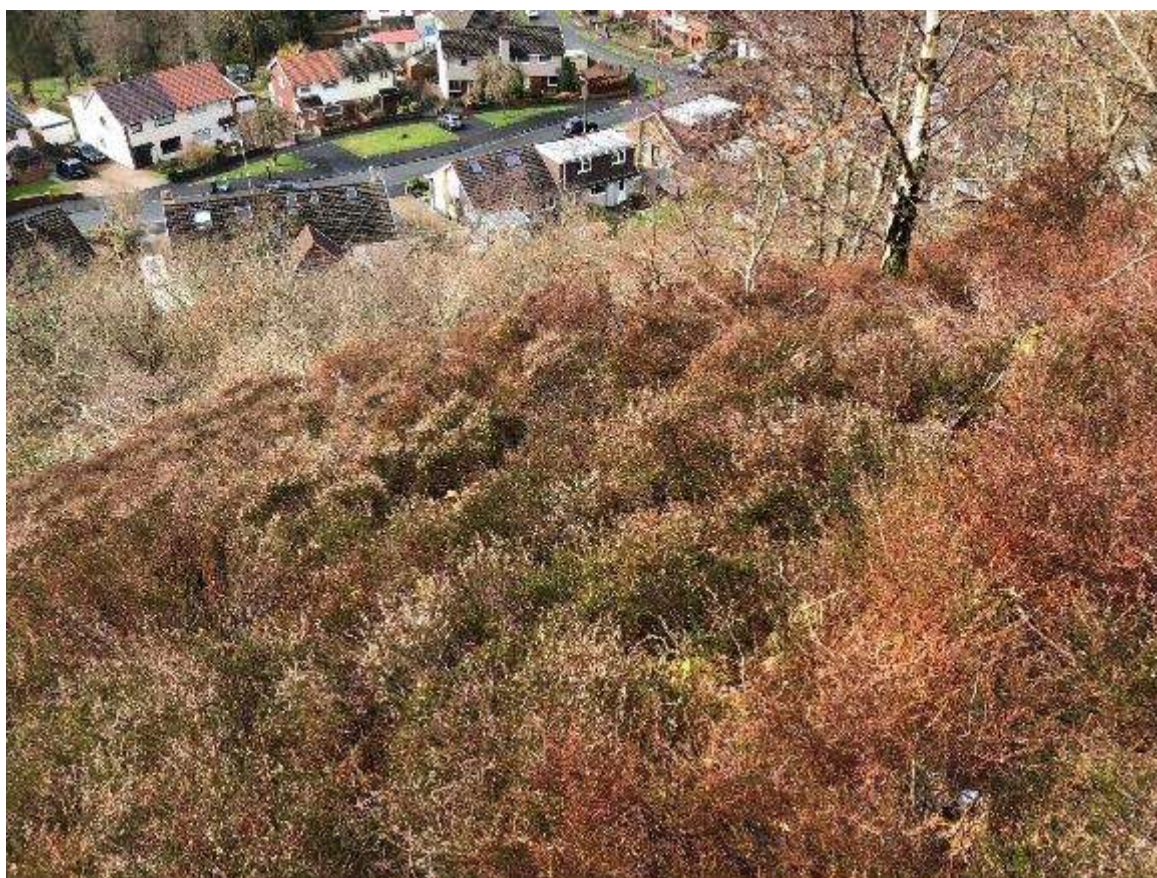
*Plate 10: View from the crest looking down the flank to Conway Drive – dense heather growth and mature trees.*

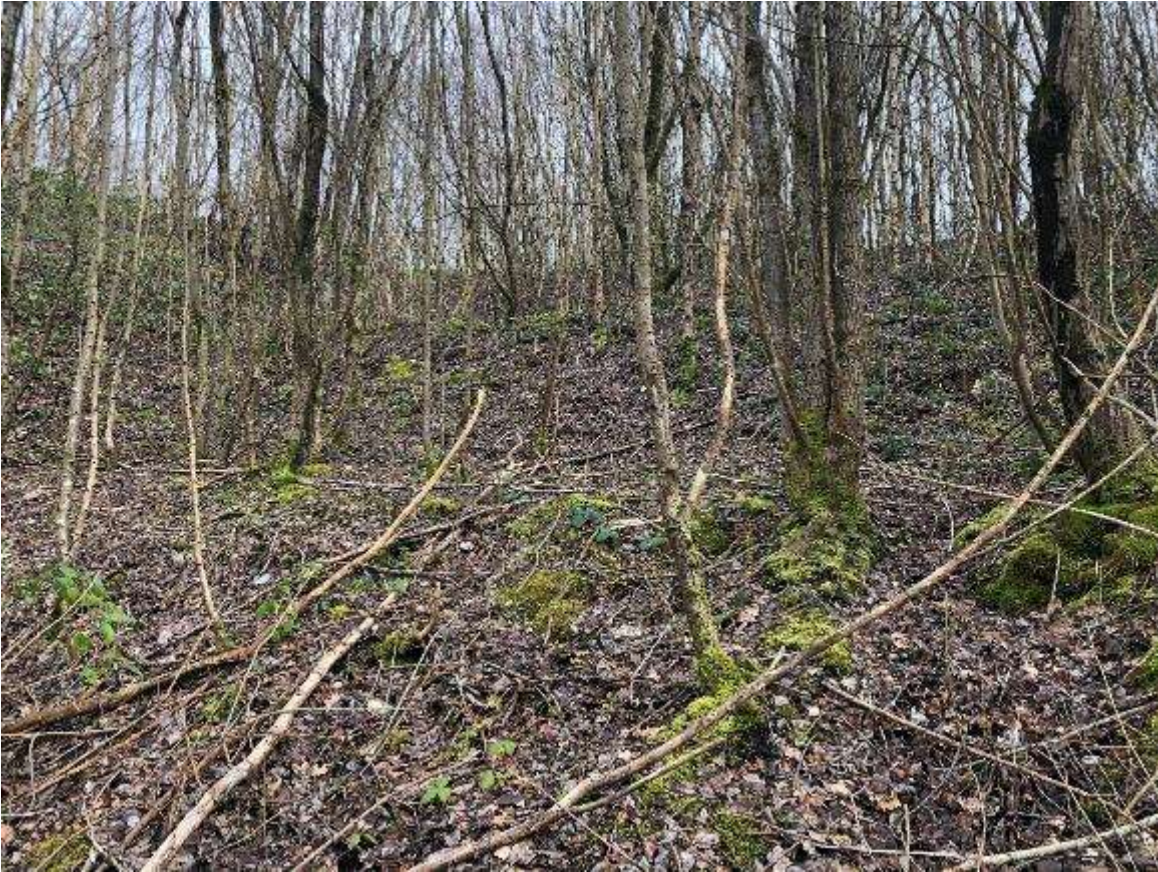
Overall the flanks appeared to be of a uniform angle from the crest to the toe. A historical feature on the western flank was observed (Plate 13), potentially an area of previous instability as a localised area of the flank has been benched. Typically this is done as a remedial measure and

could have occurred at the time of active tipping. Below this area many of the trees displayed distorted trunks potentially indicating longstanding / on-going creep (Plate 15).

*Plate 13: Benched area from the crest to mid flank on the western side of the tip.*

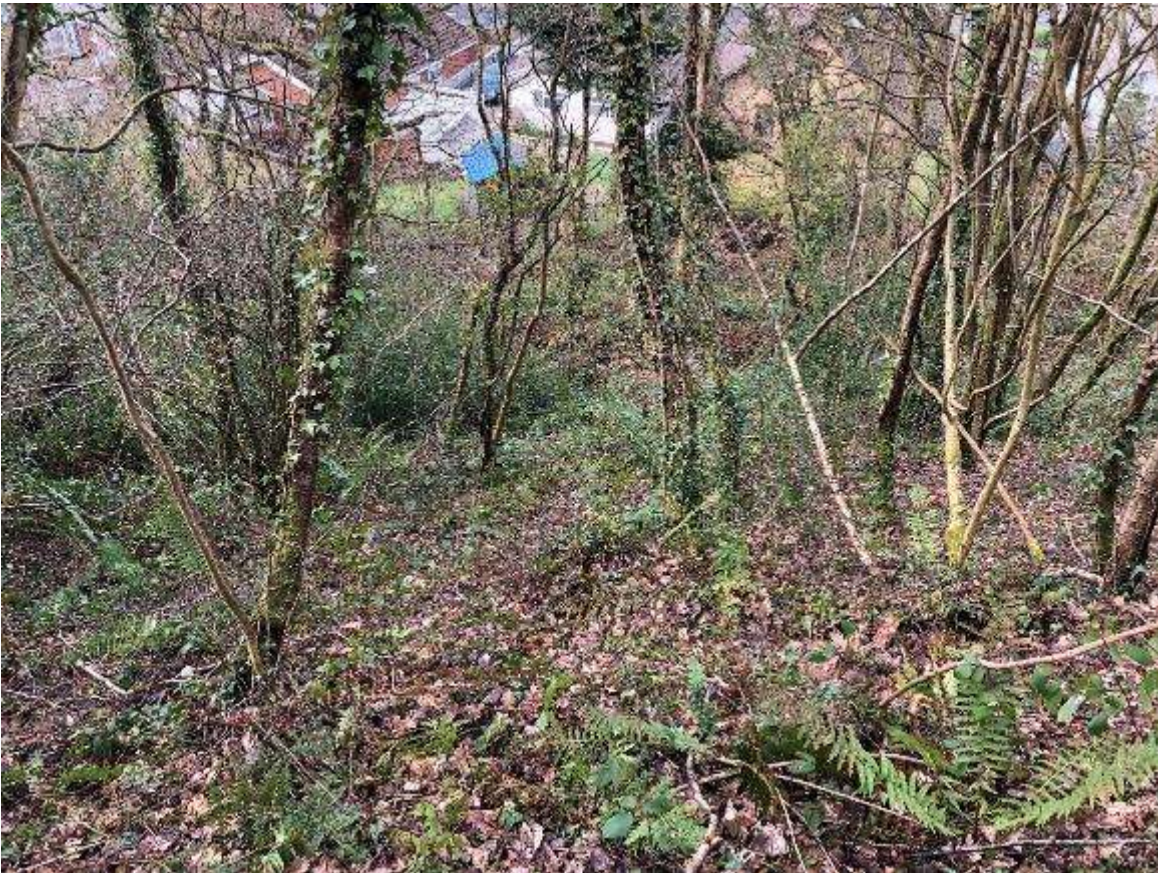
*Plate 14: View looking down the western flank at Cenarth Drive.*

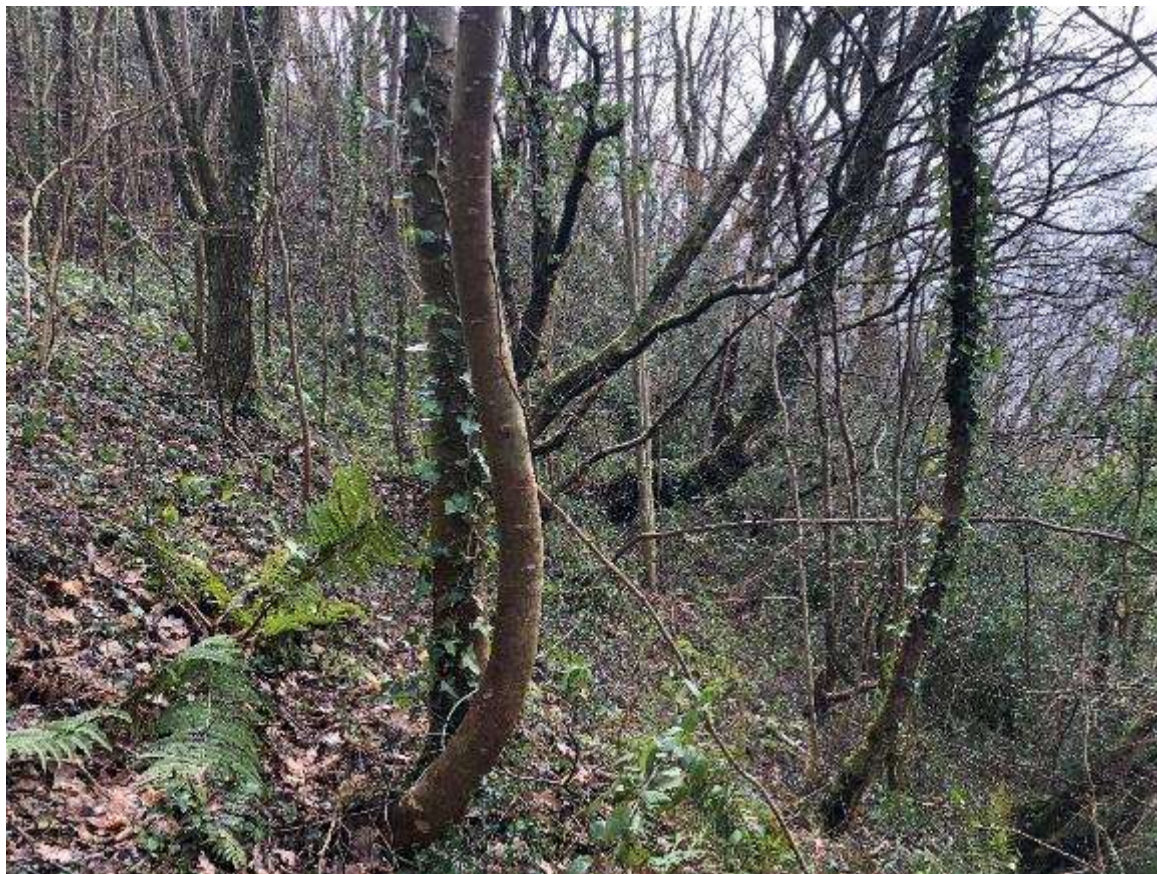
*Plate 15: Distorted tree trunks on steep section of western flank above Cenarth Drive.*

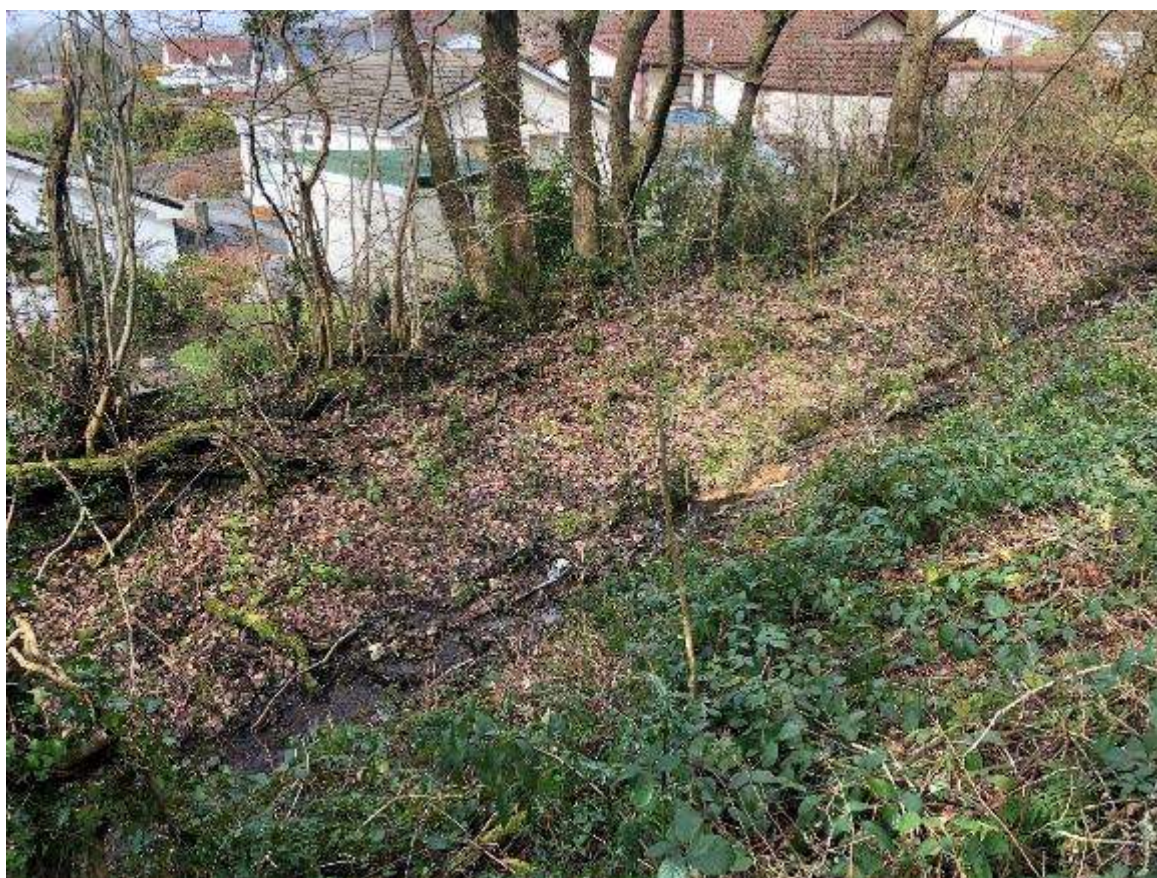
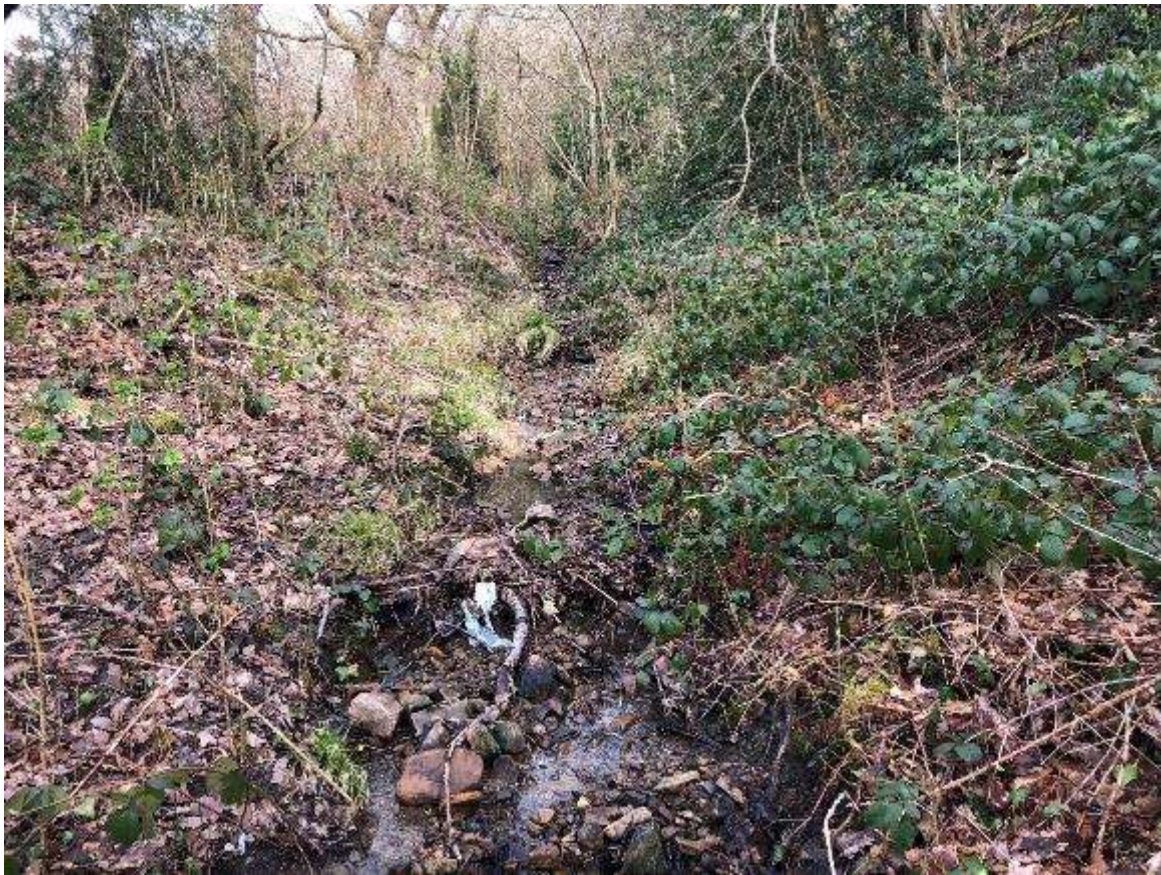
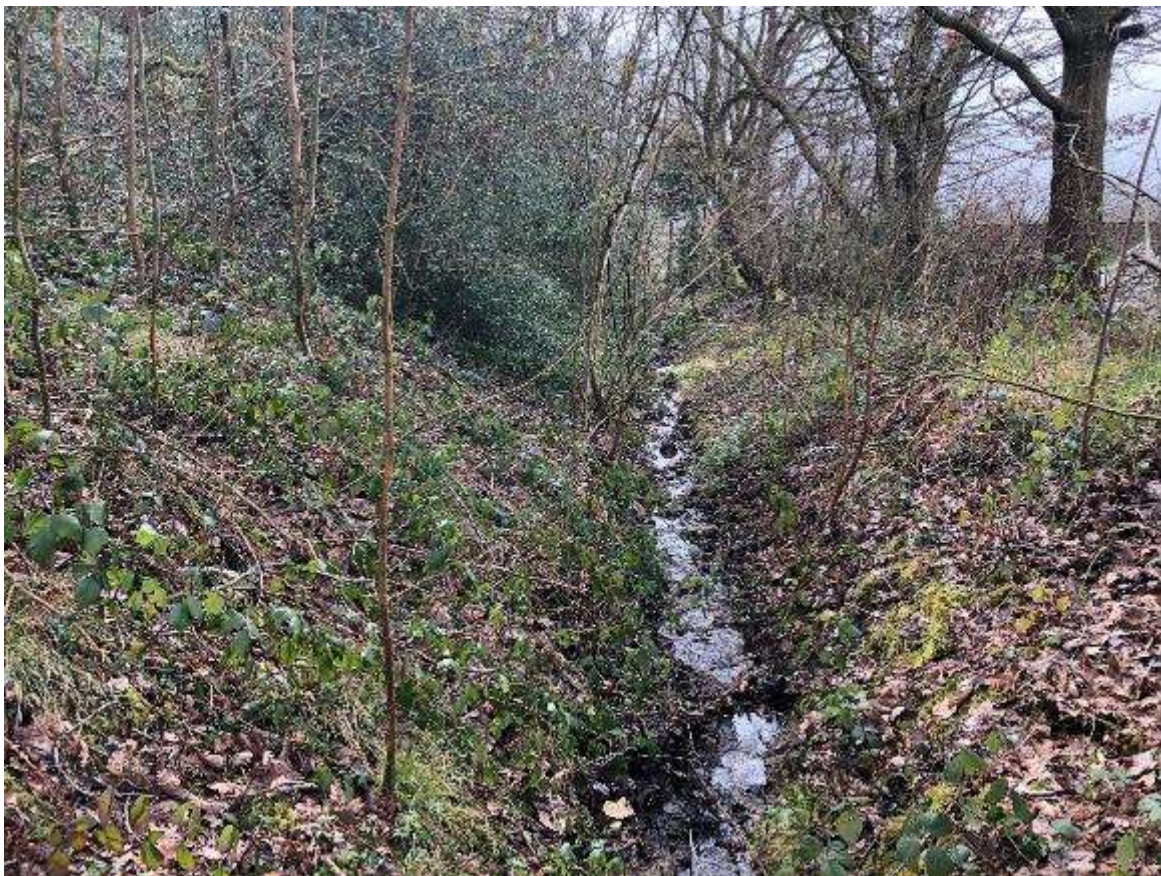
Seepage from the tip itself was not evident at the time of the inspection. The unlined cut-off ditch located on the western toe was conveying flows. Flows arising from the flat boggy ground to the northwest were being drained by the western cut-off ditch.

*Plate 16: Unlined cut-off ditch running along the toe of the western flank.*
